F-8-94

C. Repp Farmstead

Johnsville, Maryland vicinity

Maryland Historical Trust State Historic Sites Inventory Form

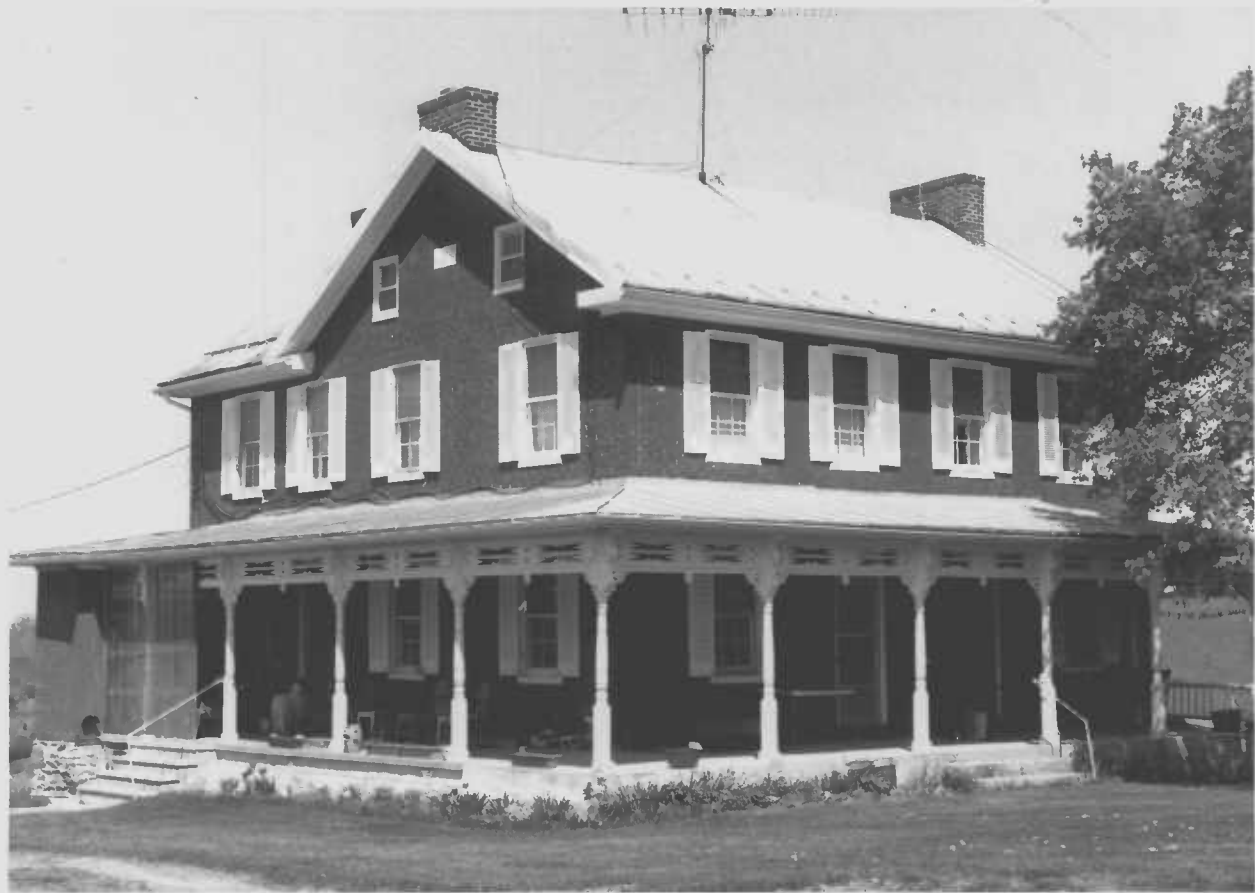
1/4

The dwelling house is a four-bay, two-story building with a rear ell built in 1853, according to a stone in the west gable inscribed "Built by C. Repp and Wife August 1853." A two-story frame addition filling in the angle of the ell was completed in 1990. This addition has vinyl siding, 1/1 aluminum sash, and a concrete block exposed foundation. The principal facade of the house is the south elevation, which is sheltered by a one-story porch extending around to include the west elevation. The porch has elaborately designed scroll-sawn trim and turned columns on a concrete deck, undoubtedly a replacement of the original floor. The porch appears to date from the last quarter of the 19th century. The facade has double entry doors in the style of German houses in the region. The sash is 6/6 and wood louvred shutters flank the windows. The roof was originally wood shingles, which are still in place under standing seam tin. The soffit has been recently covered in aluminum. The interior end chimneys appear to have been rebuilt above the roof. A third chimney is located at the north gable end of the ell. The foundation is stone and is exposed at the north end of the ell.

House, southwest corner view

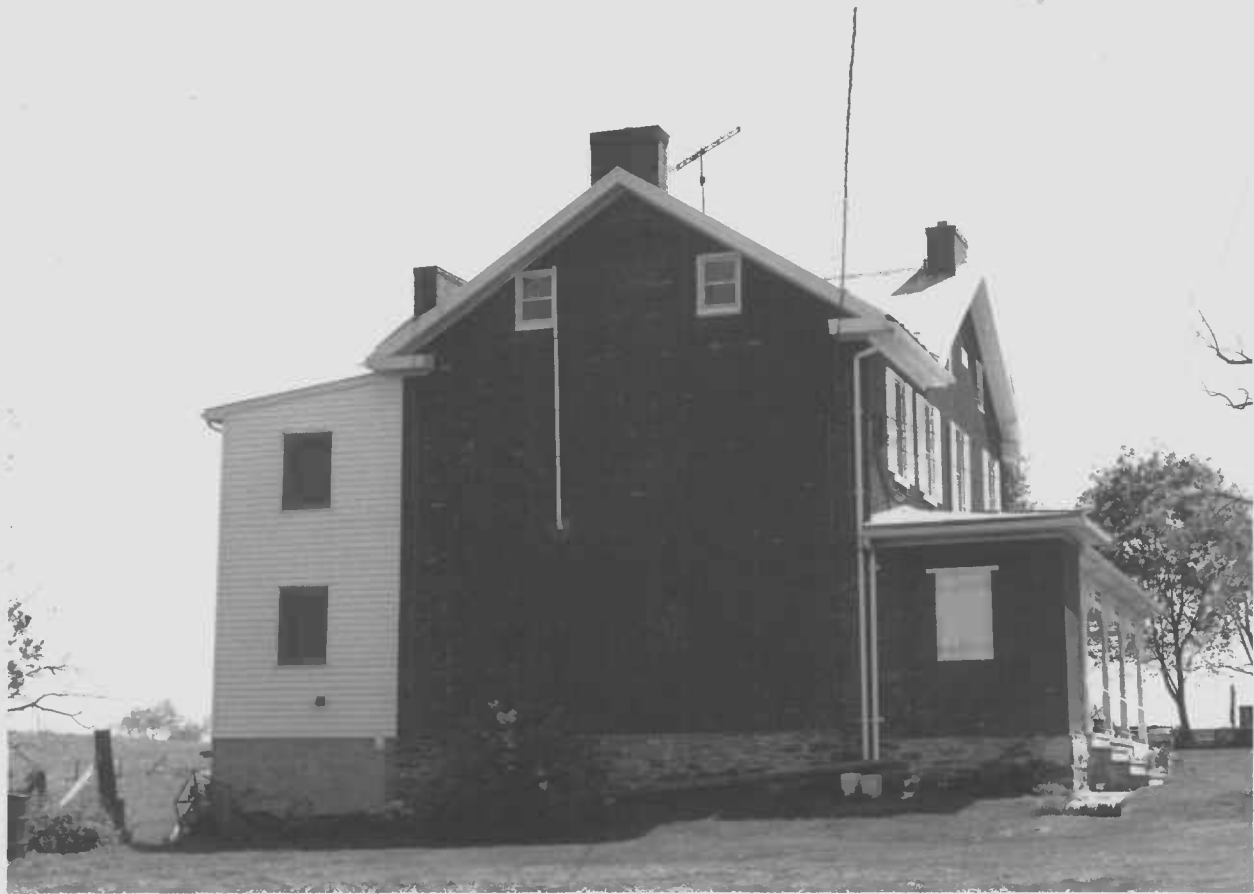
2/4

House, north elevation

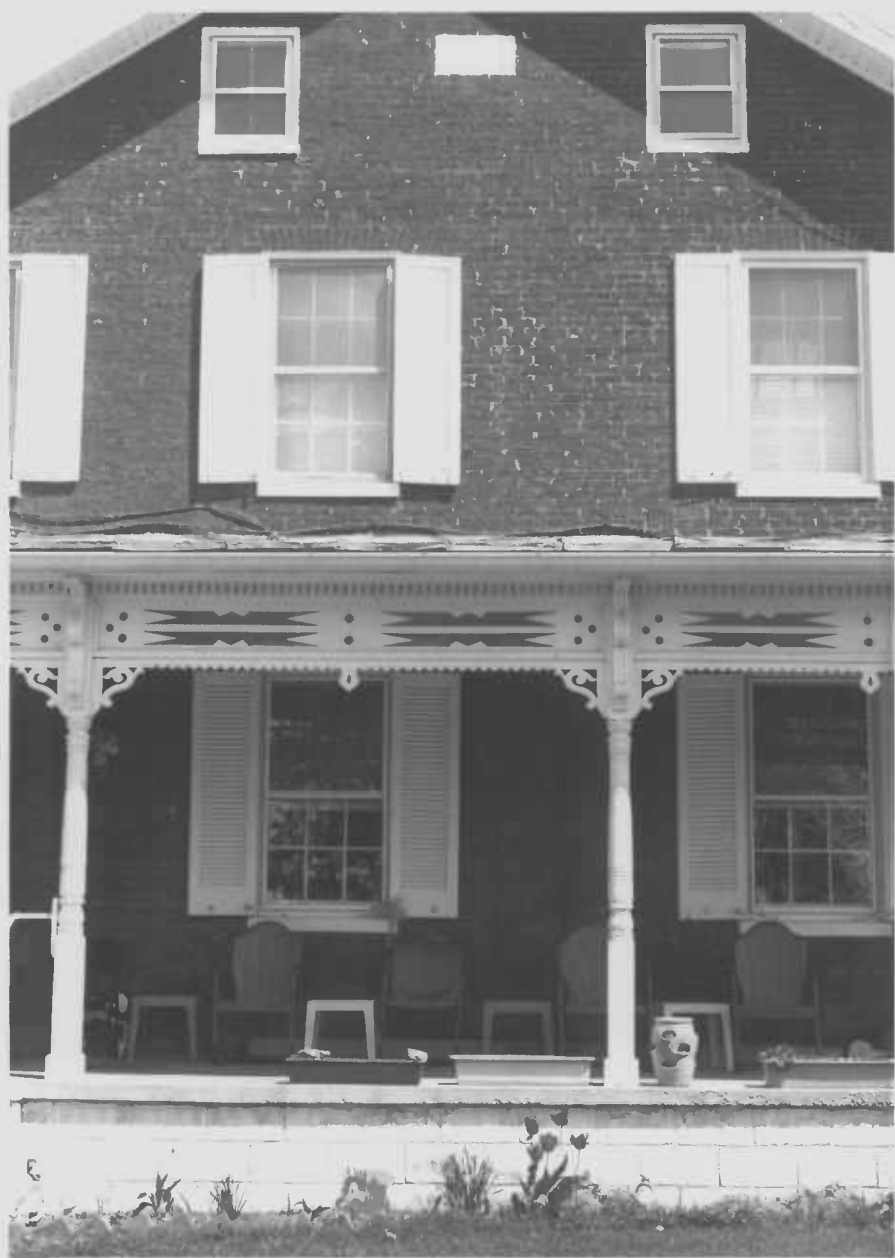
3/4

The C. Repp Farmstead exemplifies a typical agricultural group of the second half of the 19th century, containing an 1853 dwelling house, a circa 1899 frame bank barn, and several domestic and agricultural outbuildings. The scroll-sawn decoration on the porch of the house is particularly rare.

House, detail of trim

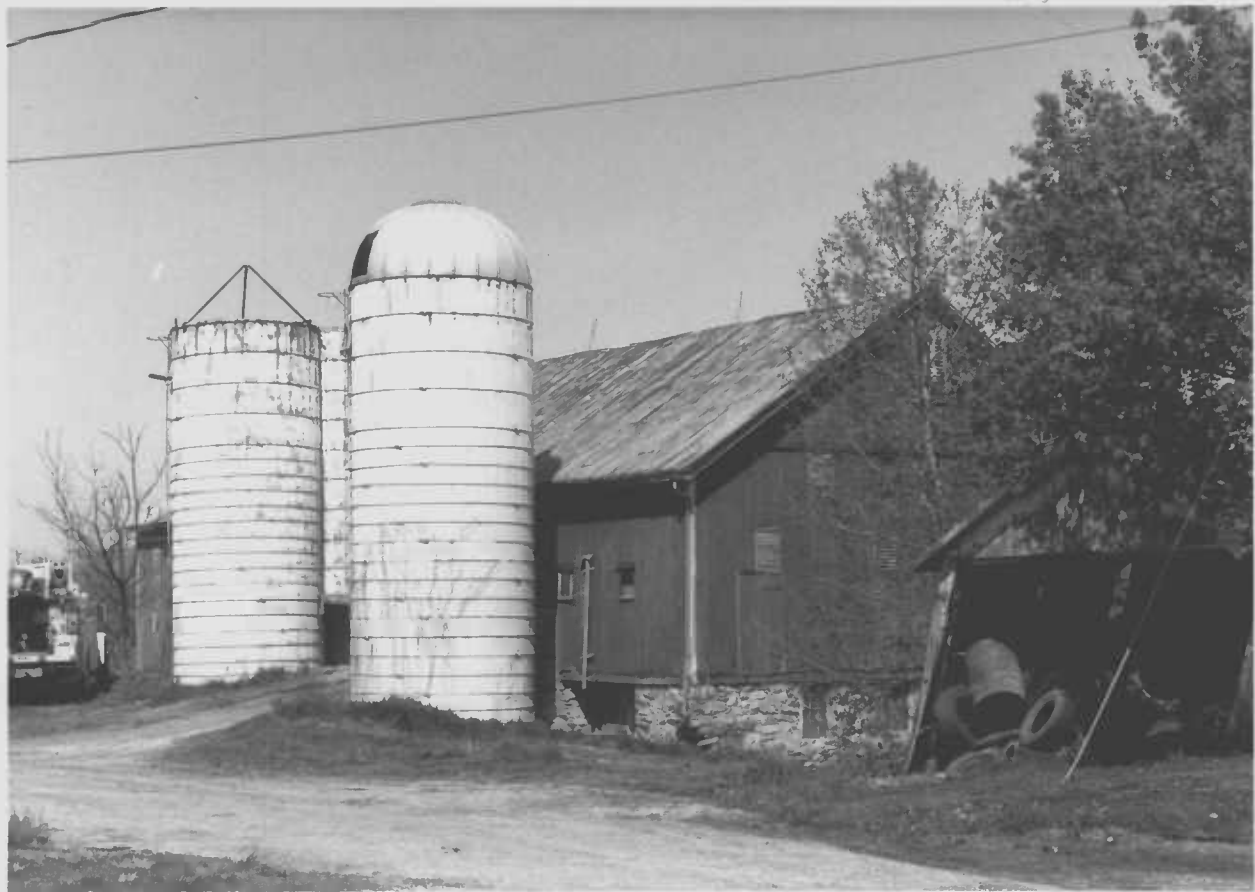
4/4

Bank barn: The bank barn is a frame building on a stone base erected about 1899, according to Mr. Kemp, the current owner. It has plain louvred vents in the gable ends, a standing seam metal roof, and two concrete tile silos flanking the ramp to the barn floor.

Bank Barn, South west corner view
